## The State of Oil & Gas Waste Management Facilities & Environmental Compliance in the Albertine Graben Region of Uganda

**CSCO Research Paper No.2, 2015**

**Civil Society Coalition on oil and Gas in Uganda (CSCO) is hosted by  
Advocates Coalition for Development and Environment (ACODE)**

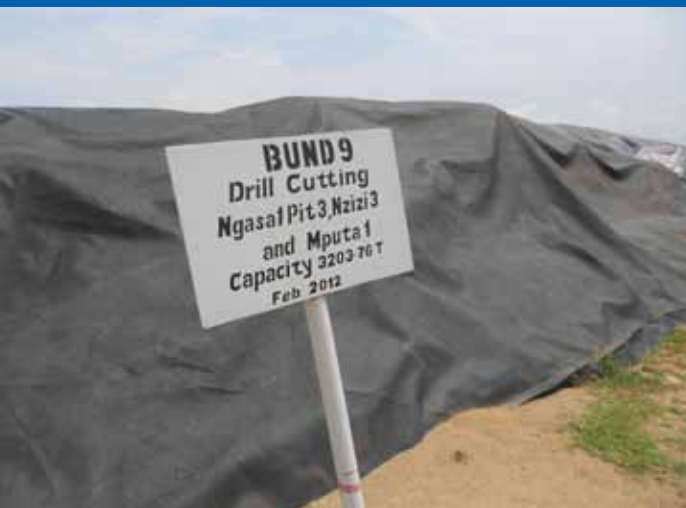
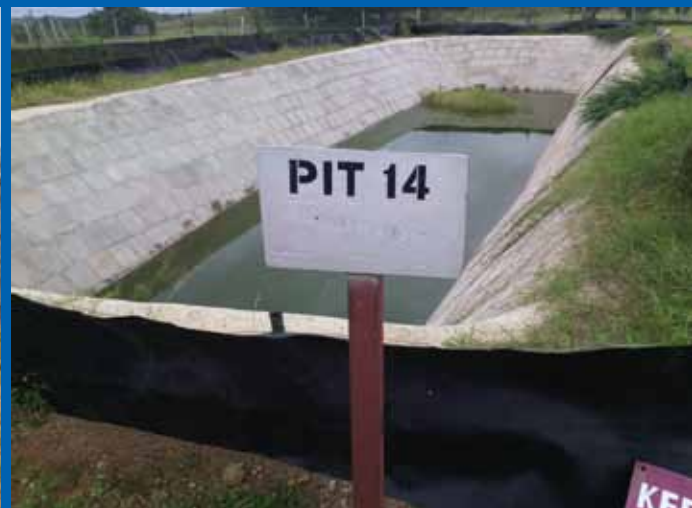
**Cover Photographs:**

The cover photographs demonstrate both good and bad environmental practices of covered and uncovered oil waste pits. Covering the pits controls pollution.

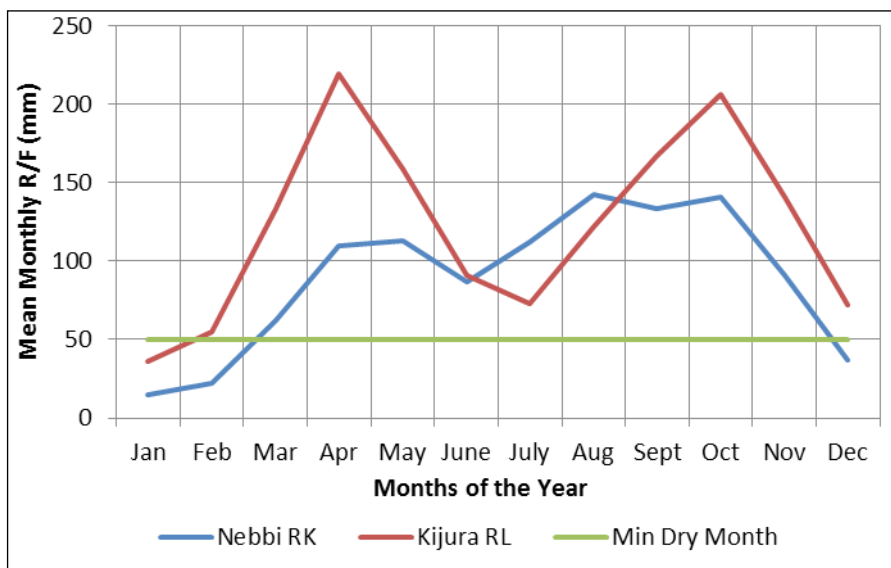
**Figure 3: Mean monthly rainfall for two representative stations in the waste management areas in the Albertine Graben of Uganda**

Therefore, from June to August that are relatively drier period in both regions are not dry months (see figure 3). Thus, the difference of the rainfall climatology of these regions arises from region K to the north being drier with a longer dry spell from December to February while in the wetter region L, only the month of January is dry (see figure 3 below for Wadelai/ Nebbi Meteorological Station representing region K and Kijura representing region L).

Notable feature of the rainfall distribution in region K, figure 3, is the apparent limited effect of the saturated south easterly monsoons during the “long rains” of March to May which

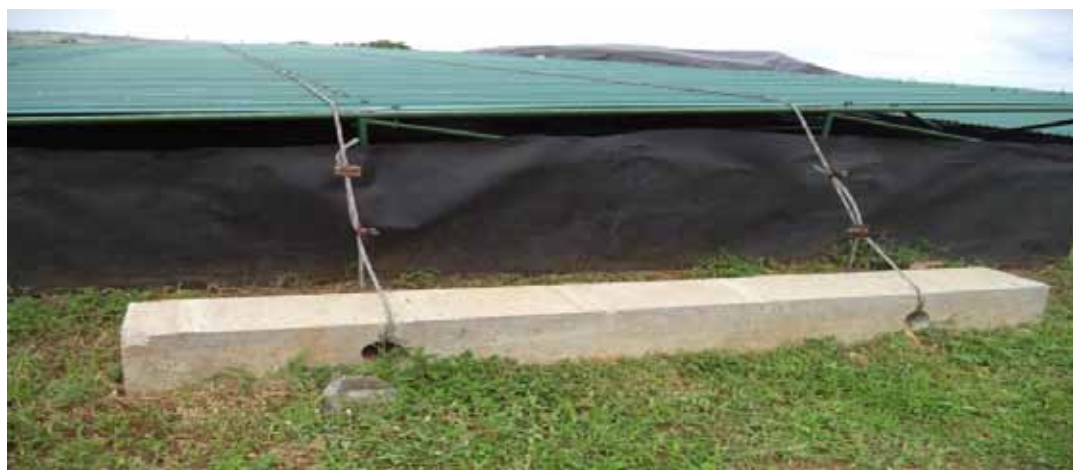
**Picture1: Showing materials used to prevent wind from blowing off roofs at one of the liquid waste containment cells at Kisinja WCA**

However, the team was informed through interviews with site technical officers at Kisinja, that wind is a major challenge during the rainy season. It blows off roofs from the Liquid waste containment cells. This suggests that the rainfall seasons in region L are characterized with thunderstorms which are usually accompanied by severe winds. Such winds affect (i) the transportation of waste materials and (ii) lead to air pollution from the sites to the surrounding areas. Therefore, measures need to be put in place for sites in region L to control pollution and guard against all possible effects of severe winds, especially during the rainy seasons (See picture below indicating wind barriers at one of the liquid containment cells at Kisinja WCA).

The team further observed that apart from this one containment cell, the rest of the cells at Kisinja had no wind barriers while other liquid waste containment cells were inadequately covered. The uncovered cells pose a great potential for both surface and air pollution, especially, during the rainy season when winds at this site are intense.

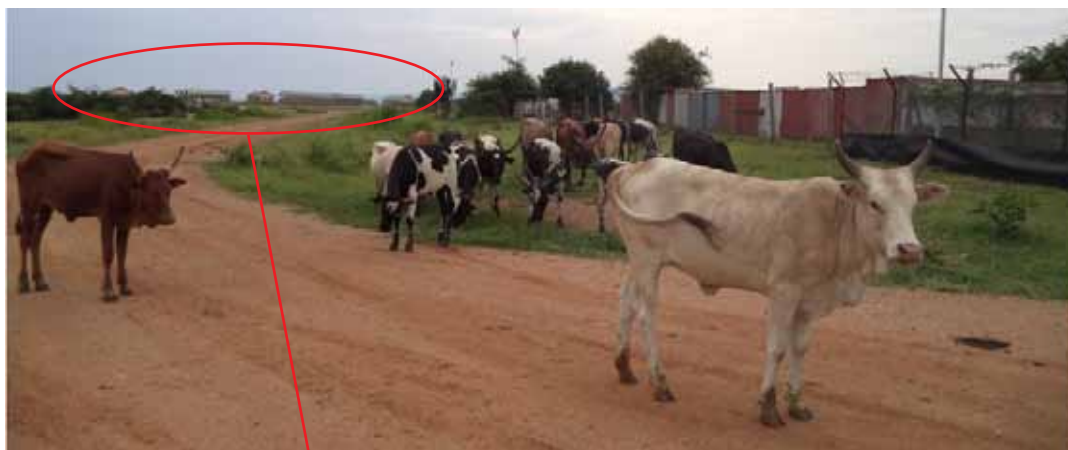
### Picture 3: Showing the nearest school to Kisinja WCA

The team noted through interviews with the Kisinja site technical officer that the nearest residential community is Kaiso which is about 3-5km away from the site. It was however observed that there exists a small residential community and a community school at a distance of approximately 10m and 500m respectively. This calls for urgent measures from the site operators to protect the nearby community and the school from any likely negative effects associated with waste consolidation<sup>10</sup>. There is also need to speed up the removal process of the consolidated wastes from Kisinja to designated treatment and disposal sites.

*Community School near Kisinja consolidation site: inset is cattle patrolling the site in search of pasture*

<sup>10</sup> Waste consolidation is associated with bad odour, and dangerous gases such as hydrogen sulphide which often drift to the nearby communities by wind, hence, posing health problems to humans. Hydrogen sulphide gas has a rotten egg-smell. The gas is flammable, explosive and toxic to the environment.

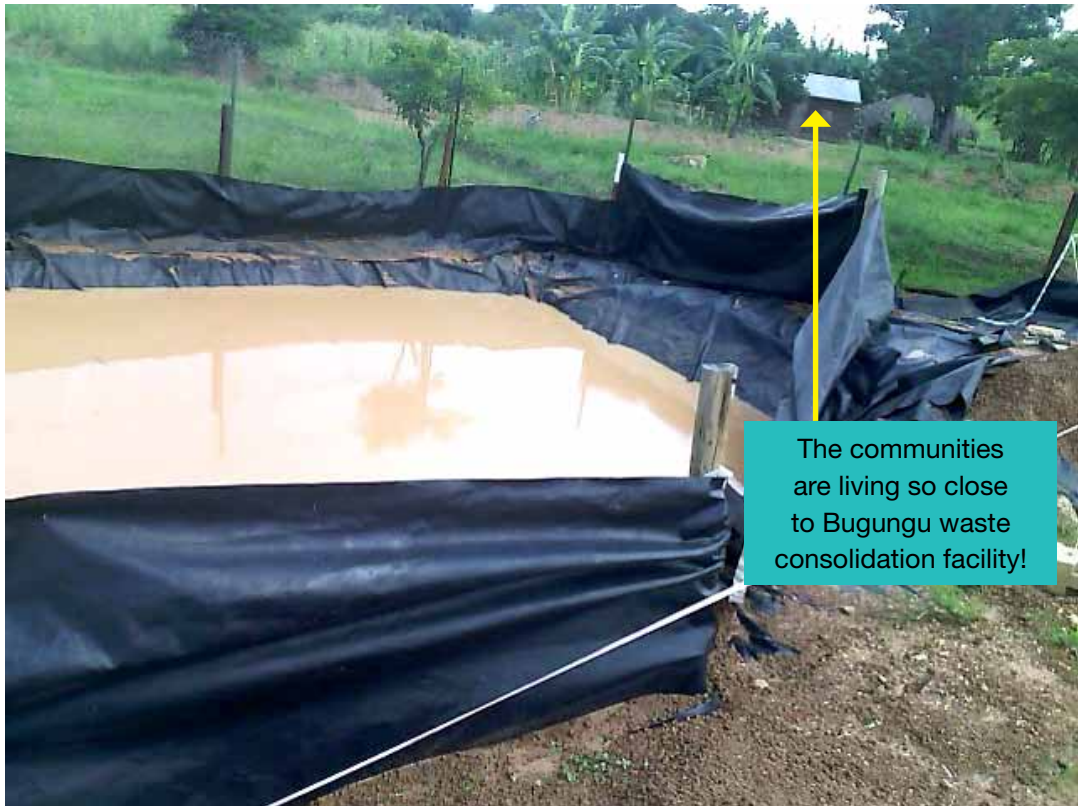
## Picture 4: Showing the nearest residential community to Bugungu WCA

The observed distance from the perimeter fence at Bugungu waste consolidation facility to the nearest residential community is approximately 10m contrary to the recommended 250m<sup>11</sup> by the IFC World Bank standards and/or the 1,000m according to the Uganda National Waste Management Regulations, or even the 500m prescribed by the National Operational Guidelines for Oil and Gas Operations. While the regulations largely apply to waste treatment and disposal sites, the interpretation can easily extend to waste consolidation facilities given the length of time the waste is contained. It was noted that Totale E&P had embarked on the process of removing this waste to the treatment and disposal plant in Nyamasoga, but considering the time it would take to completely clear this site and as long as waste is still consolidated at this site, adequate measures and steps need to be put in place to safe guard the nearby community, domestic animals and wildlife from the potential adverse impacts associated with waste consolidation.

It was further observed that H<sub>2</sub>S (Hydrogen Sulphide) is used on the liquid waste at Bugungu site, as such, there was an intense strange smell within and outside the site. Studies indicate that Hydrogen sulfide in the atmosphere can make breathing difficult and damage the nervous system<sup>12</sup>. The more concentrated the H<sub>2</sub>S, the more pronounced its effects. It can be deadly at high concentrations. Thus, nearby communities need to be relocated or otherwise, fast tracking the process of removing the wastes from this community is required.

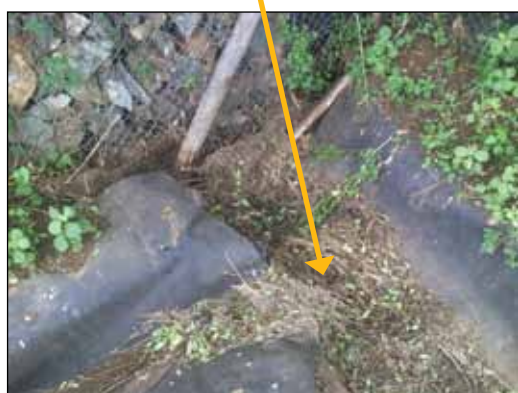
**Picture 5: Showing sediments in the Drainage channels at Kisinja WCA**

The team noted, through observation, that the site had an erosion control system and a filter barrier to prevent sediment discharge into the nearby streams. However, the drainage channels at this facility were too narrow to adequately carry large volumes of storm water. The team further observed that the runoff-flow pipes and the filter barriers had been covered by sediments and overgrown grass. This limited the smooth flow of storm water to the settling basins which caused spillage and meandering of the runoff water to the different areas of the site as was evidenced by the erosion and sediment marks left at the different corners of the facility. See pictures 5 and 6 below;

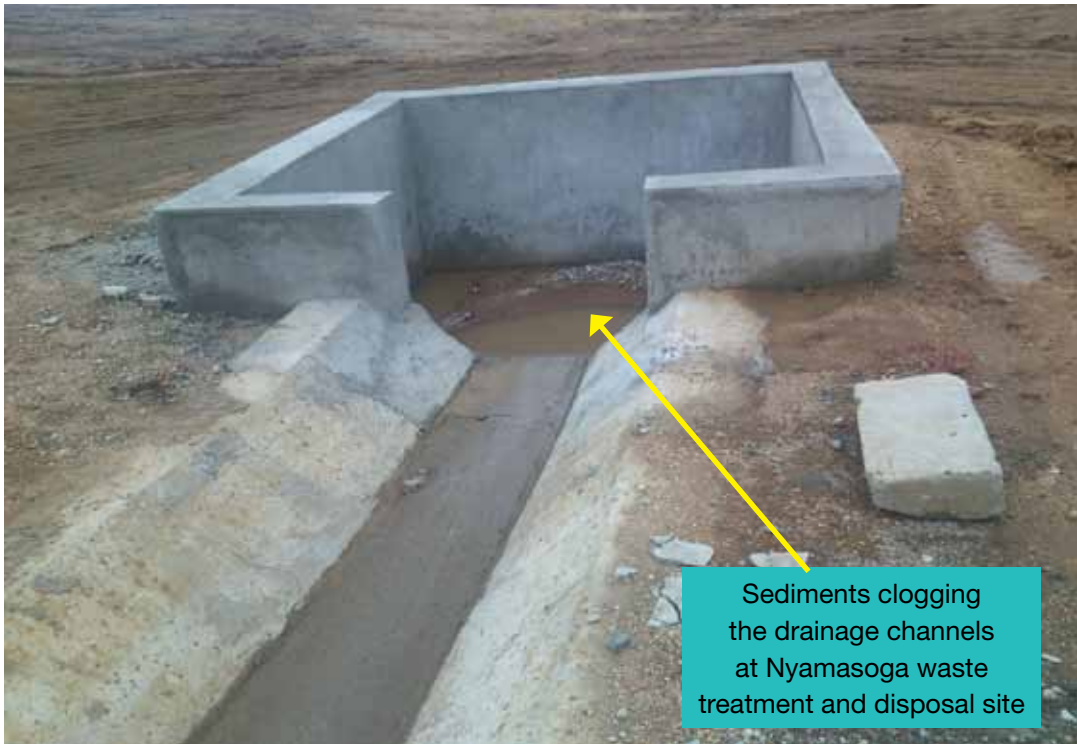
## Picture 7: Showing the nature of the drainage channels at Nyamasoga site

The team observed that both liquid and solid waste treatment was already taking place at the site. The drainage channels already in place were wide enough to adequately facilitate the flow of storm water to the settling basins even at a heavy downpour without causing back flow of the runoff to other areas of the site. By the time of this study, the settling basin for storm water was still under construction. Thus, some channels were clogged up with sediments, which called for regular monitoring and cleaning of all the drainage channels at the site to avoid problems associated with sedimentation.

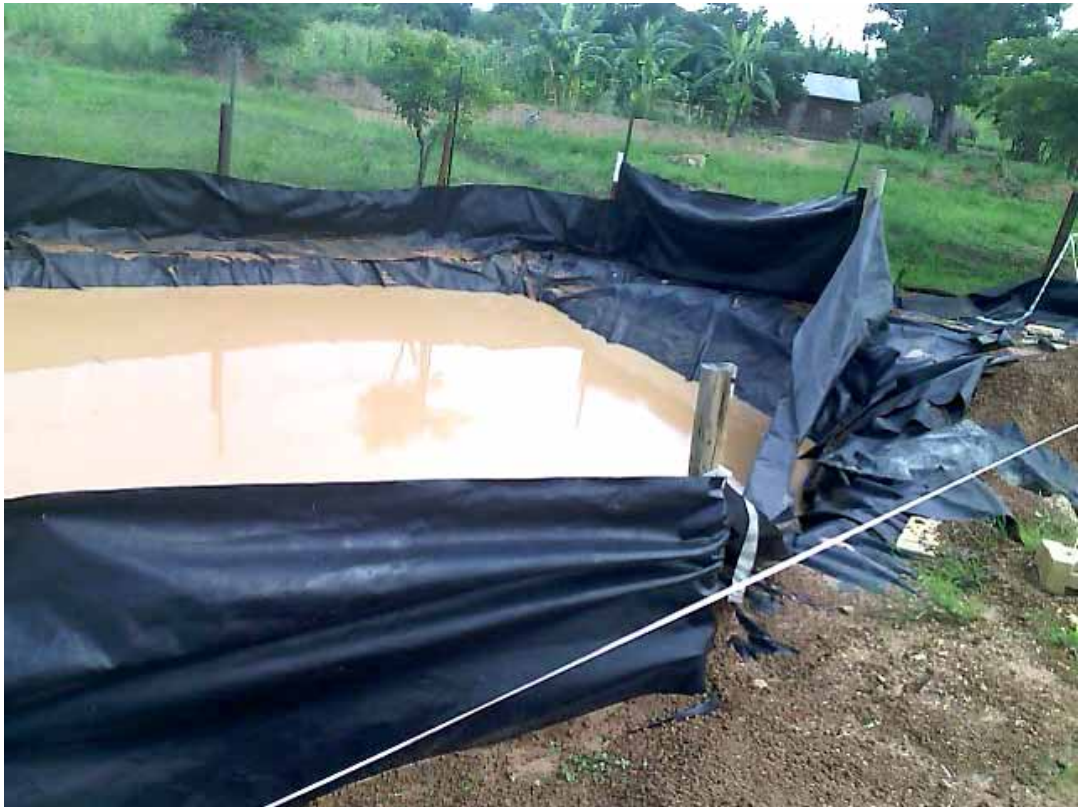
**Picture 8: Showing a storm water settling basin with no drainage channels or filter barriers at Bugungu WCA**

The team observed that the erosion and sediment control system at Bugungu WCA was inadequate to control storm water from running to the nearby communities and surrounding environment. The only erosion control component observed at the facility was the settling basin which was isolated and not connected to any clear drainage system. In other words, the facility neither had a definite drainage channel system nor filter barriers to separate sediments from the storm water. As such, marks of erosion were observed almost everywhere within the facility.

As long as the Bugungu waste consolidation facility was still in use, the project operators need to establish a temporary but adequate drainage and sediment control system at the site to protect the nearby communities and surrounding environment from the negative effects of erosion and sediments running from the facility to the surrounding areas.

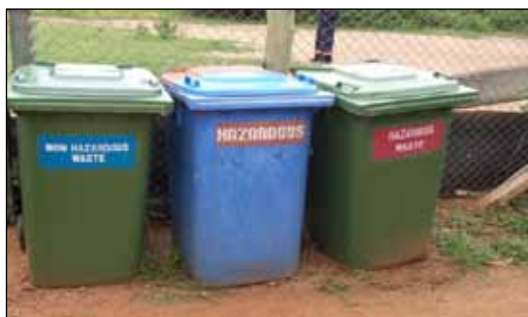
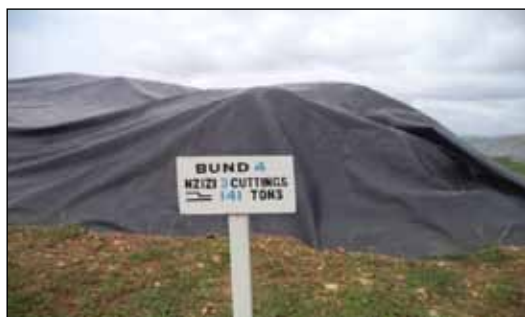
#### Pictures 10 and 11: Showing separate receiving and handling equipment for the different types of waste, and Geo-referencing of the burial cells

The team noted, through observation that all the 3 sites were well labeled and demarcated with separate receiving and handling areas/equipment for hazardous and non-hazardous wastes. The sites had all the waste burial cells clearly geo-referenced, indicating the source, type, and volume of waste contained at each of the containment cells.

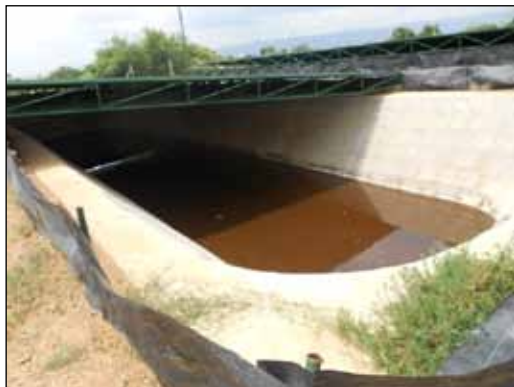
**Picture 12: Showing a poorly covered Liquid waste pit at Kisinja WCA, July, 2014**

The team noted, through observation, that some of the liquid containment cells at Kisinja were inadequately covered. For instance, one of the containment cells had stayed uncovered for at least one year considering the previous CSCO's visit at this site in July, 2014.

Kisinja WCA is located in Region L of the rainfall climatological zones which receives an annual average rainfall of over 1400mm with over 130 days of rainfall associated with winds. The team established that, the uncovered liquid waste containment cells were affected by the intense rains and winds, hence posing both surface and air pollution threats to the surrounding environment, wildlife, and human communities. The operators of Kisinja waste consolidation site should therefore consider adequately covering all the

waste containment cells at this site or rather speed up the removal process of wastes from this site to final treatment and disposal facilities. This so as to avoid and/or minimize the potential environmental risks associated with poor management of hazardous waste.

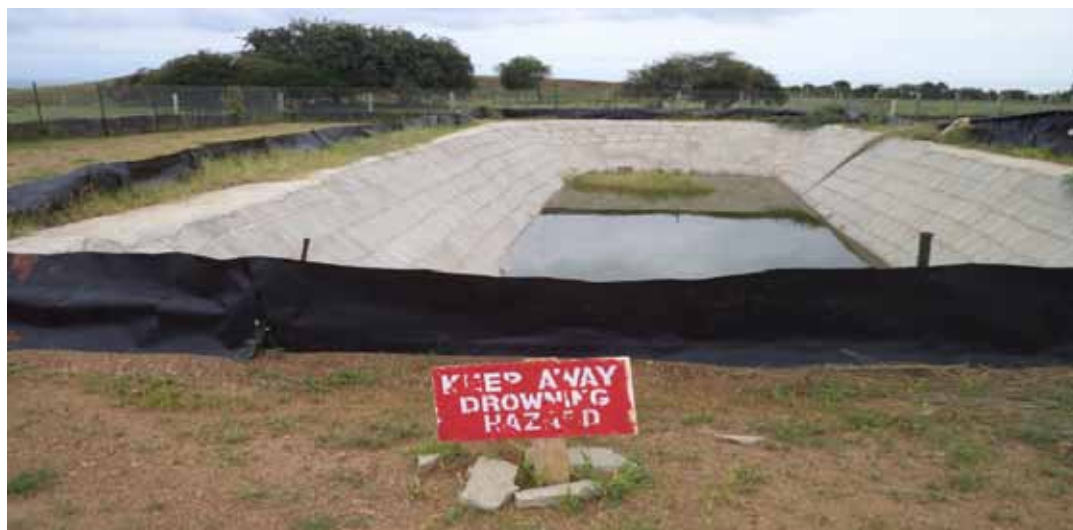
**Picture 14: Showing the new and uncovered emergency liquid waste pit at Kisinja WCA**

The team further noted, through interviews with the Site technical officer, that there was another new liquid waste pit which, by the time of the study, had remained uncovered for at least 7 months (See photos: 12, 13 and 14 below).

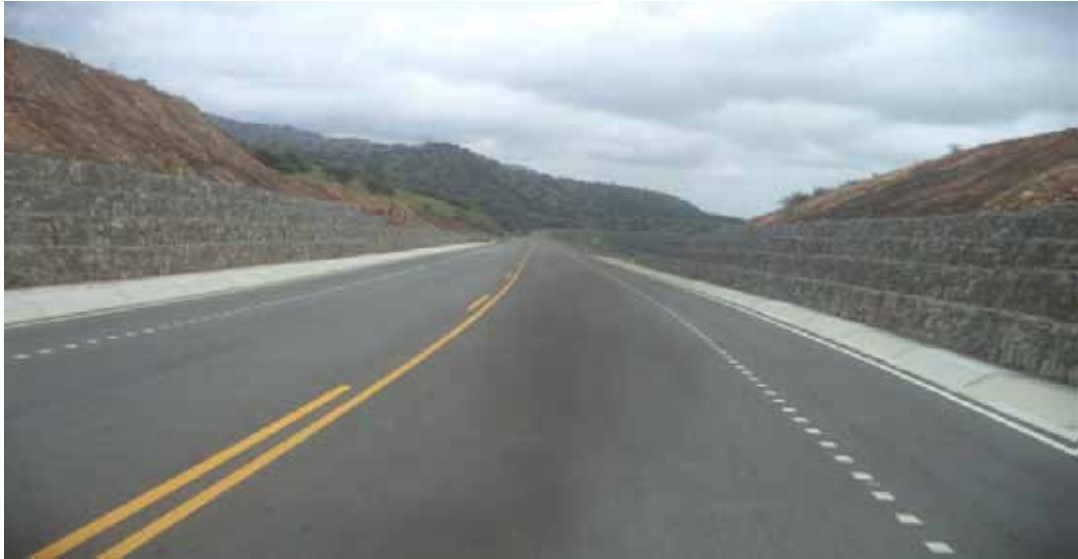
**Picture 16: Road from Hoima to Nyamasoga. Transportation of waste will require such smooth roads to avoid waste dropping**

There is need for Government to upgrade all the roads used for oil and gas transportation activities to adequately facilitate the easy movement and safe transportation of the wastes and other related oil and gas materials within the Graben.

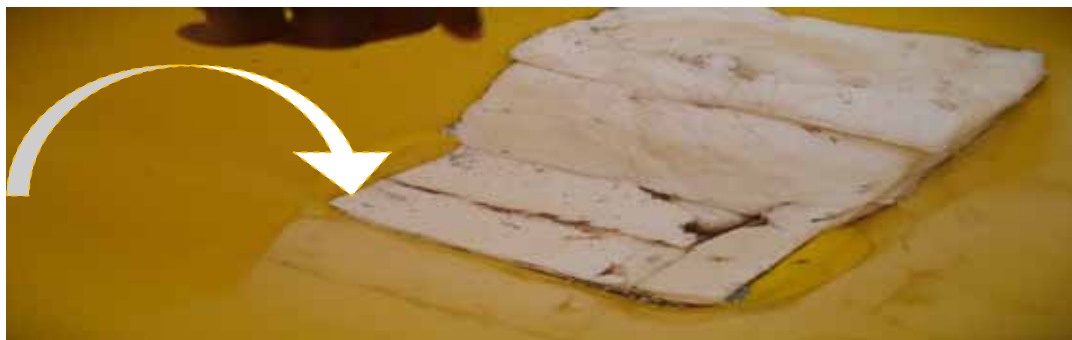
## Picture 17: Showing rusted material in the public emergency response kit at Kisinja WCA

The study found that maintenance of facility equipment at the waste consolidation facilities was inadequate. This was evidenced from a number of site equipment such as the containment cells, some of which had developed severe cracks with over grown grass protruding towards the open segment of the liquid waste. The materials contained in the public emergency response kit at some of the sites had started rusting as shown in the pictures below.
